Sarah Mildred Long Bridge

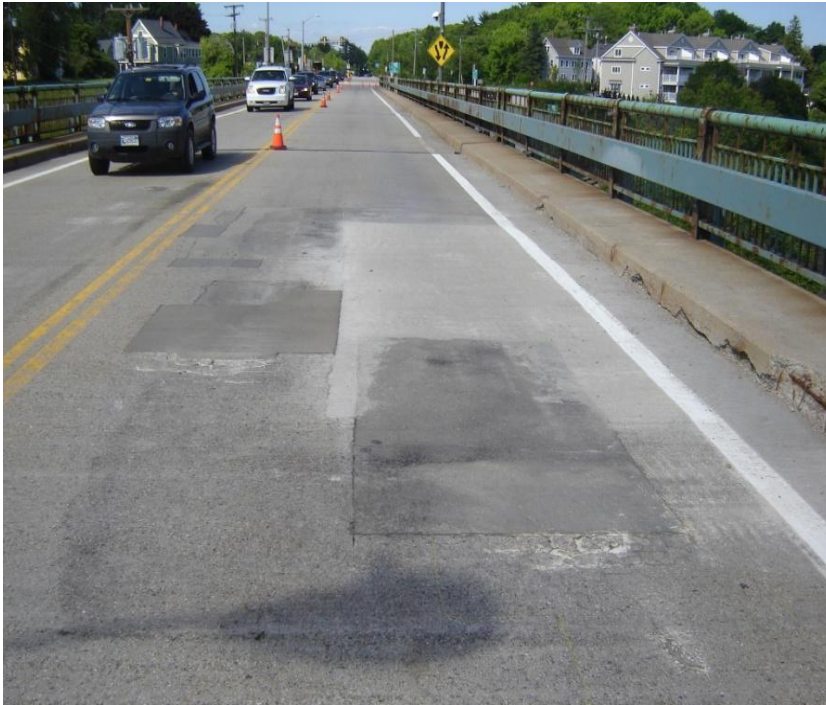
Existing Typical Deck Repairs showing signs of distress and delamination

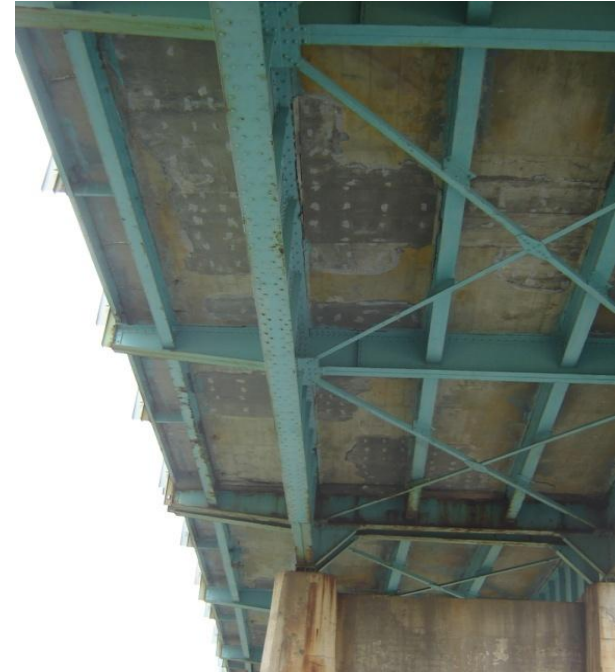
Existing Typical Deck Repairs from previous rehabilitation work

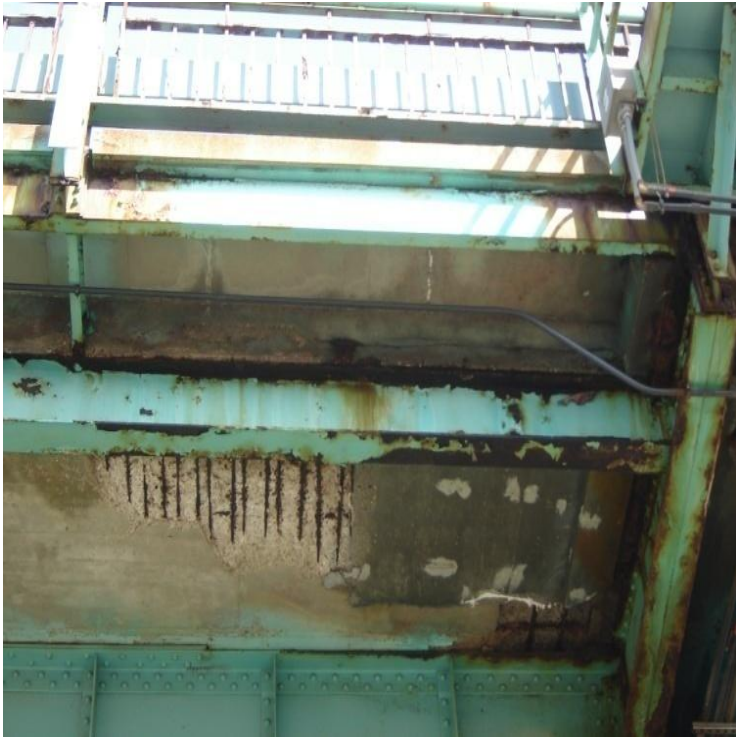
Deck spalling adjacent to a
previous repair

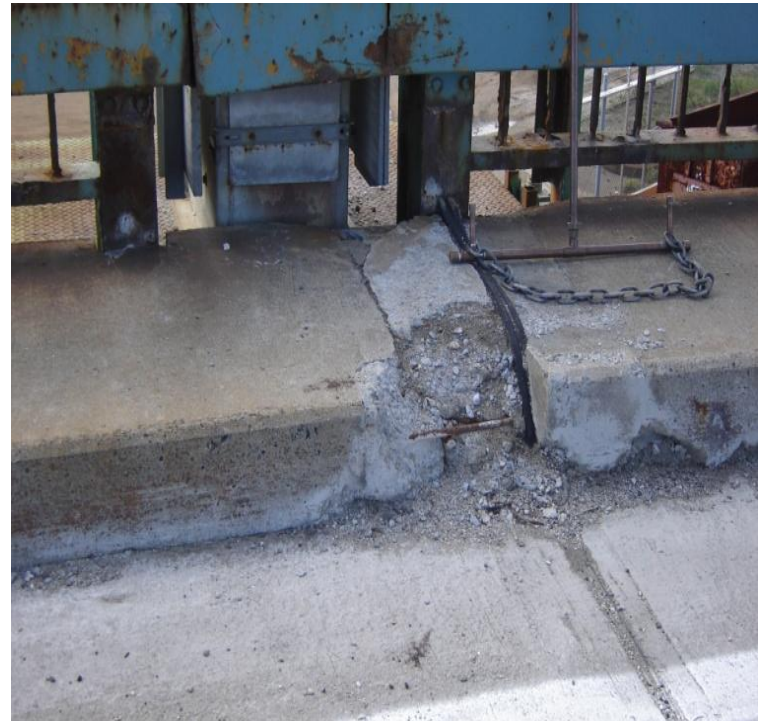
Curb and roadway joint
deterioration

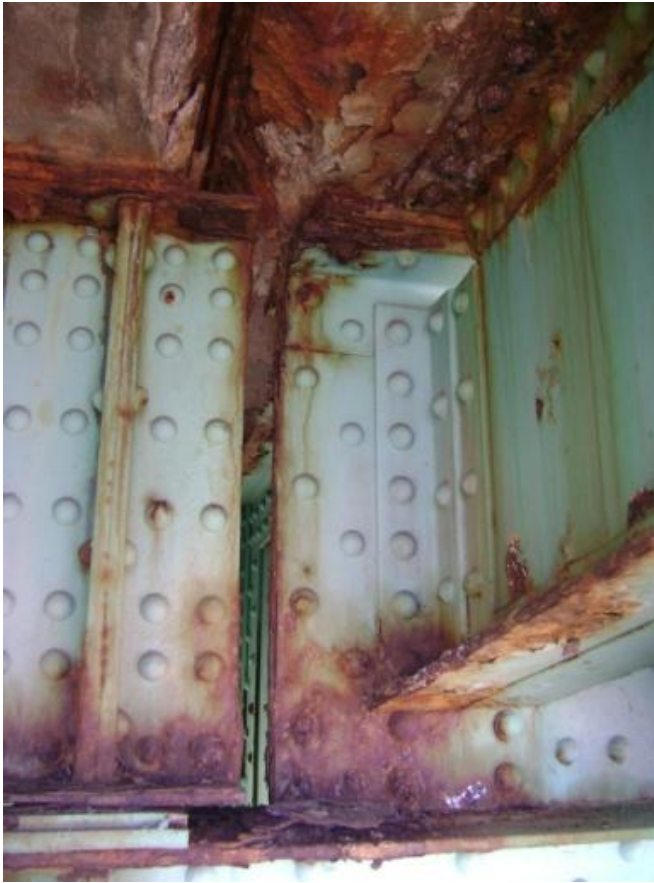
Girder hinge and expansion joint located beneath joint in roadway slab above

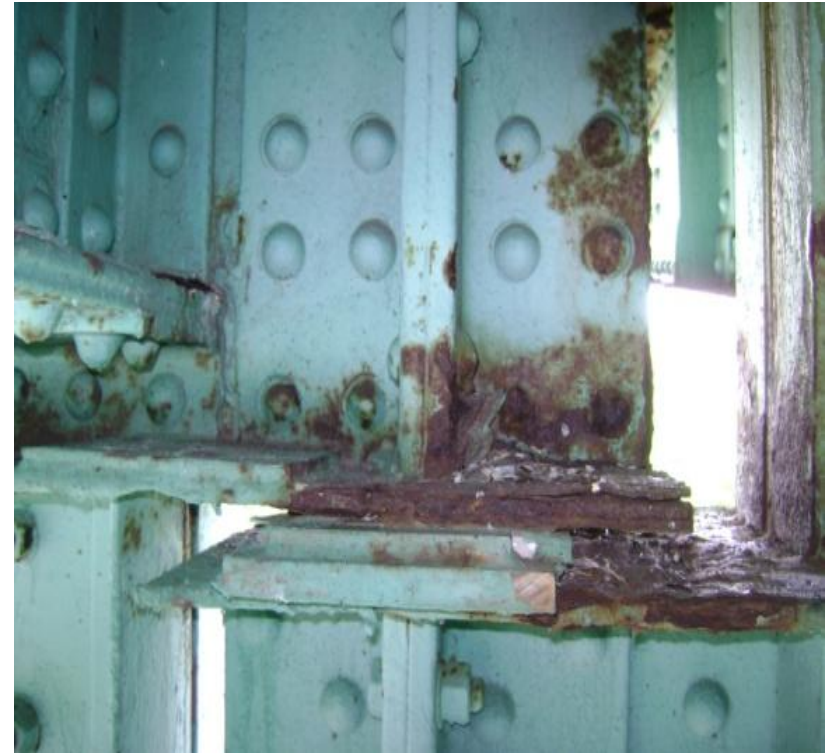
Previously repaired girder hinge seat detail showing signs of deterioration

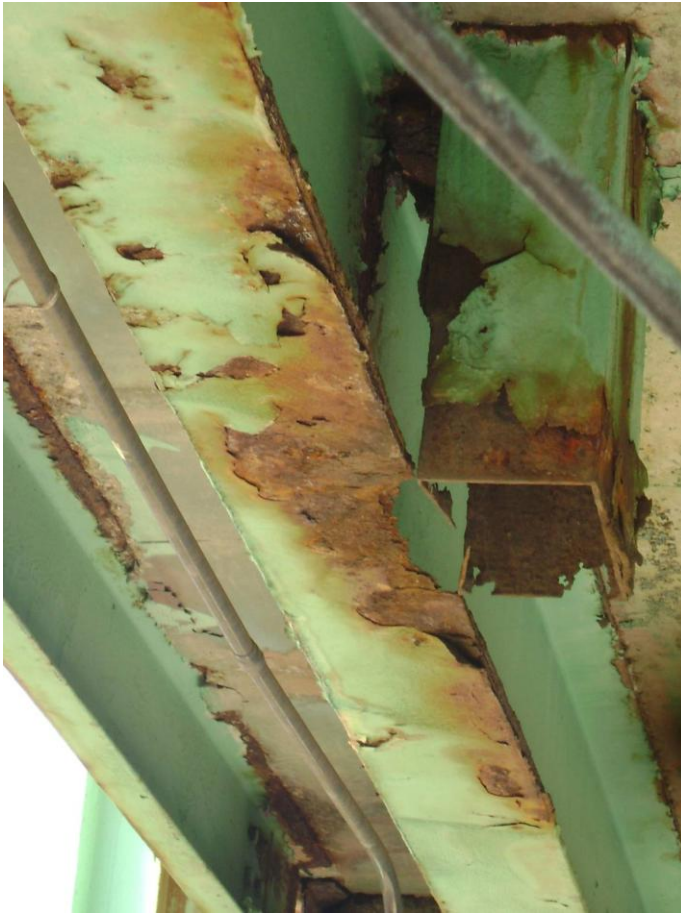
Deteriorated curb stringer
adjacent to roadway drain
downspout

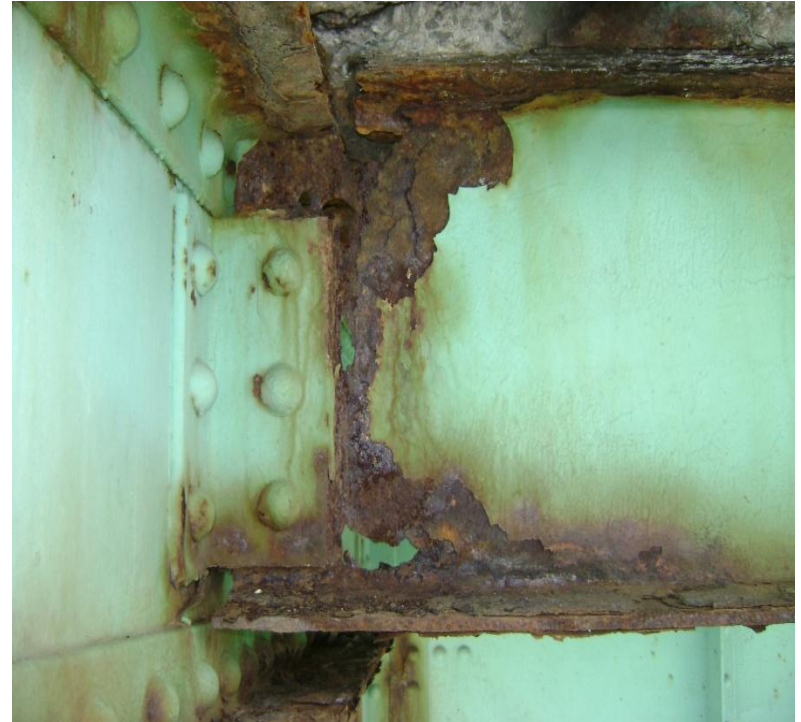
Curb stringer with holes in the web
adjacent to the clip angle connection
to roadway beam

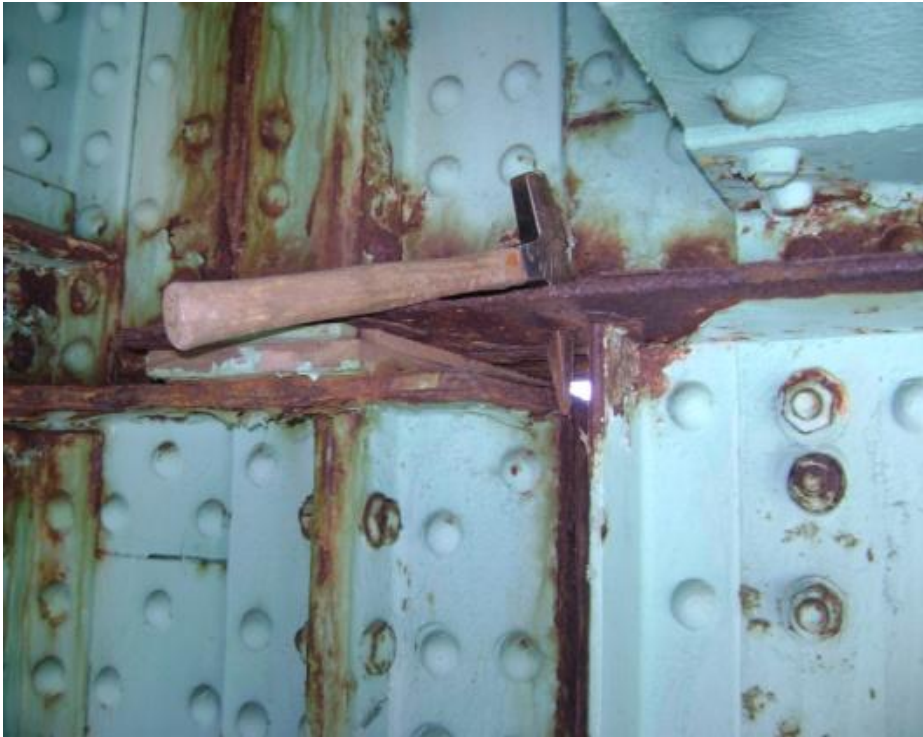
Spans 13 & 14 roadway girder hinge
deterioration

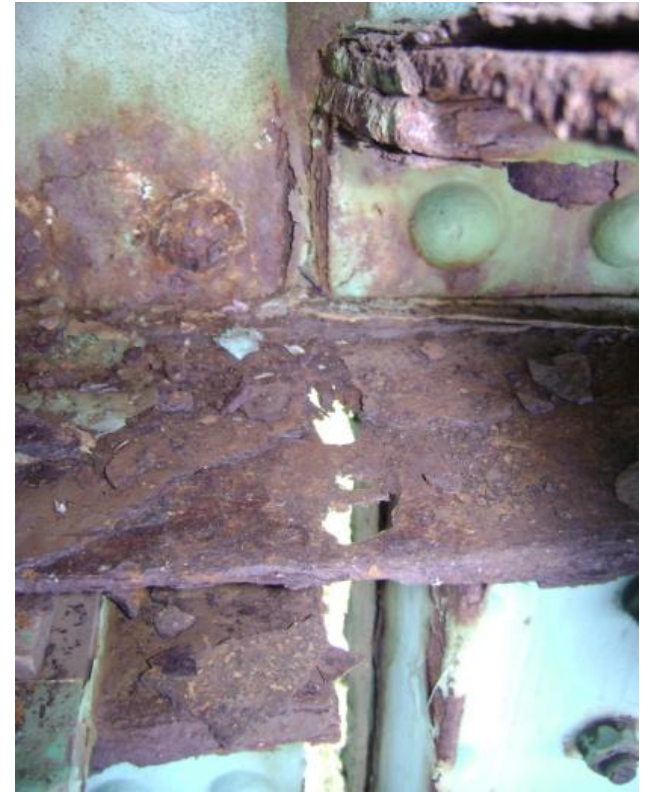
Spans 13 & 14 roadway girder
hinge deterioration

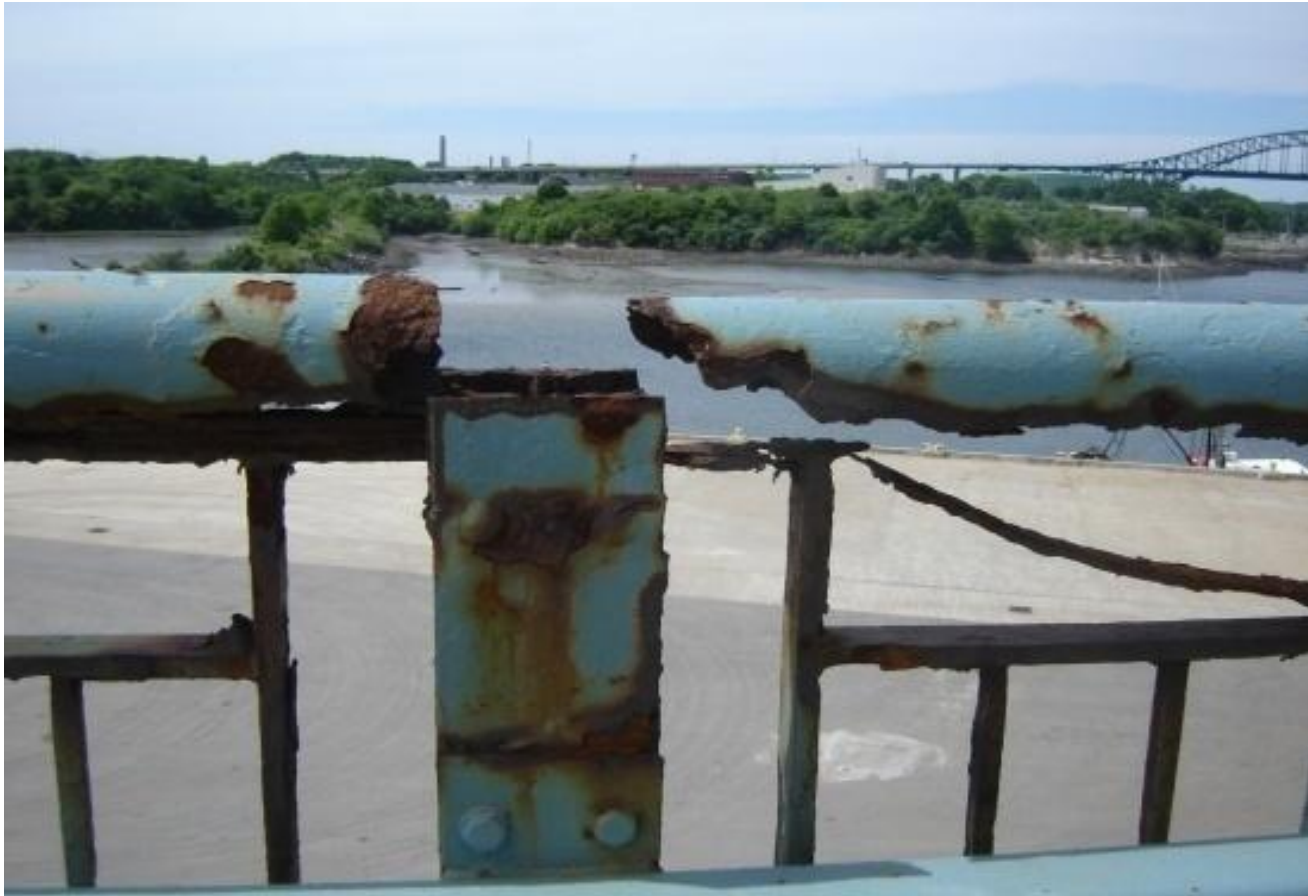
Severe deterioration at top of railing

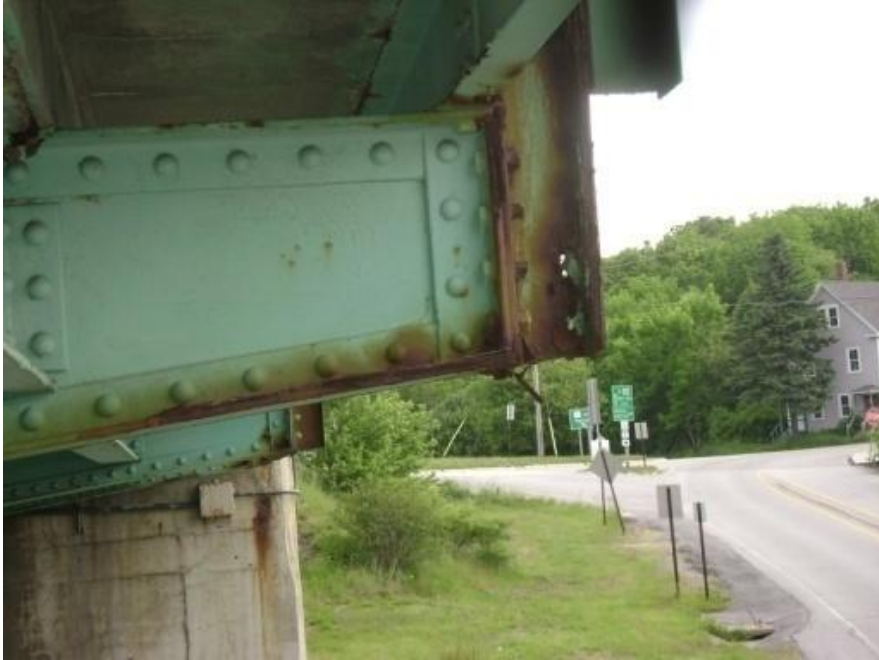
Holes in vertical railing post connection

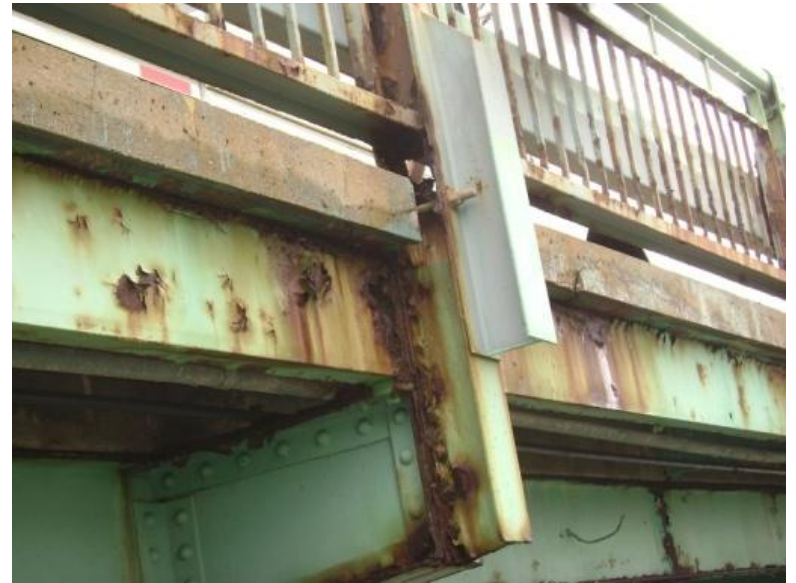
Typical deterioration and previous repair details at connection of railing post to bridge steel

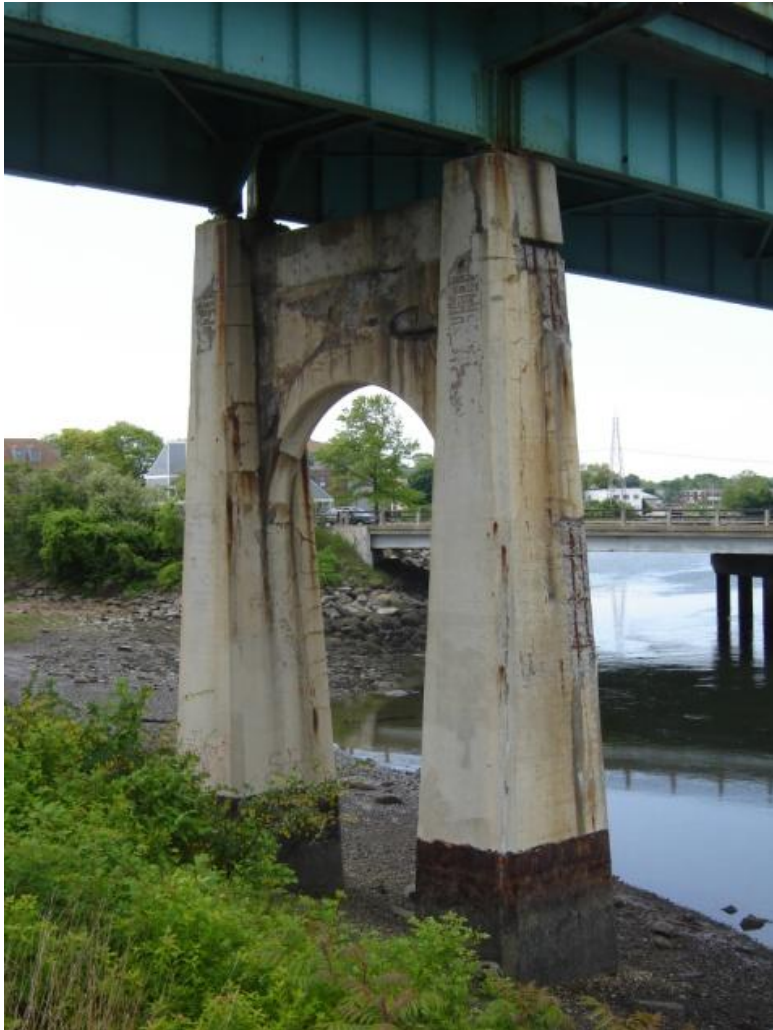
Spalling and surface
cracking at pier 7

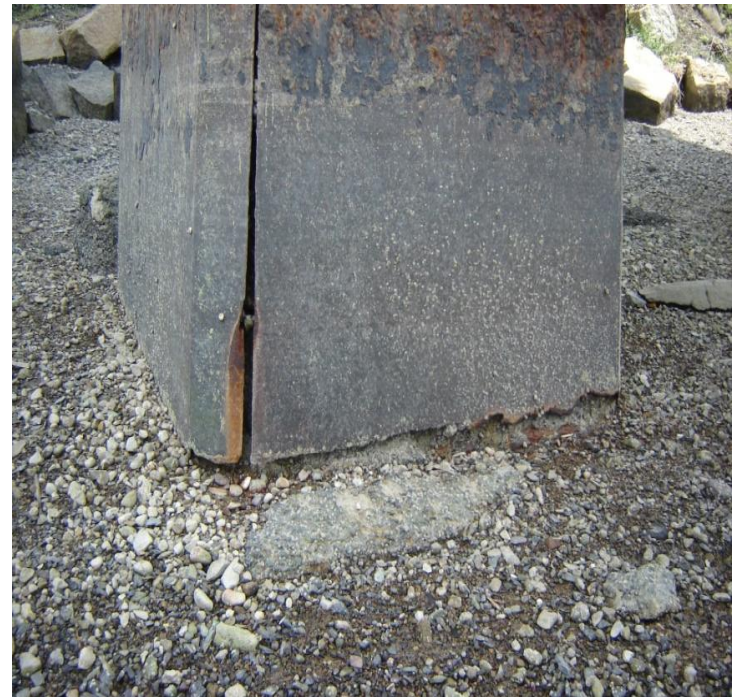
Separation of steel protection jacket
at the base of pier 7

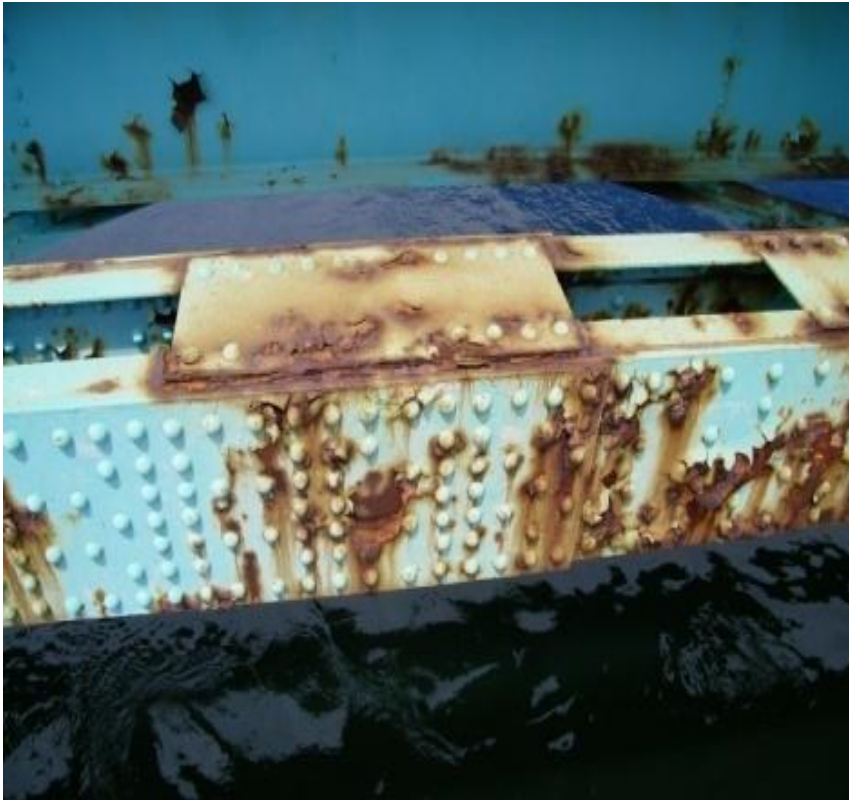
Bottom chord web and batten plate
(deterioration from drain overhead)

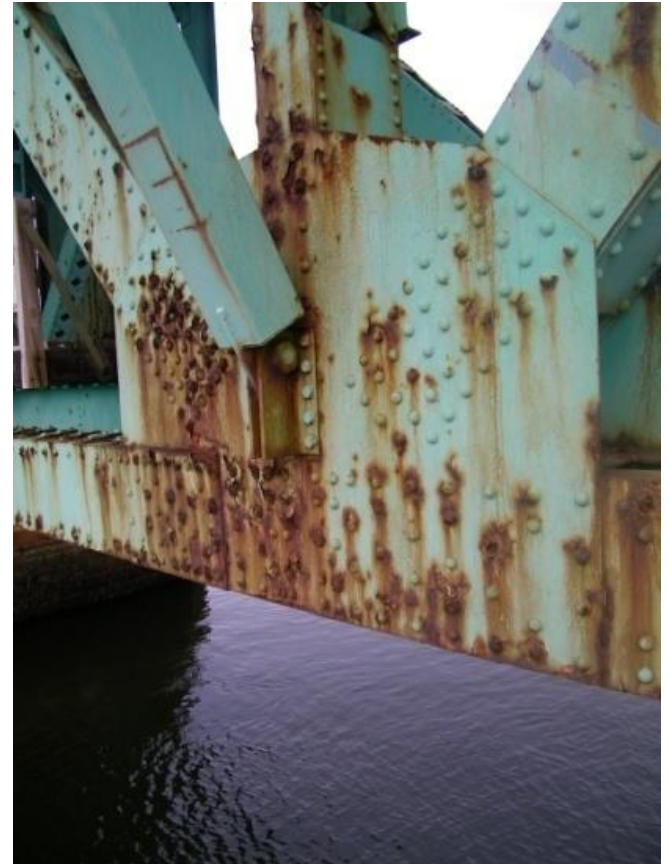
Condition under operator's house

Examples of paint system condition and levels of deterioration

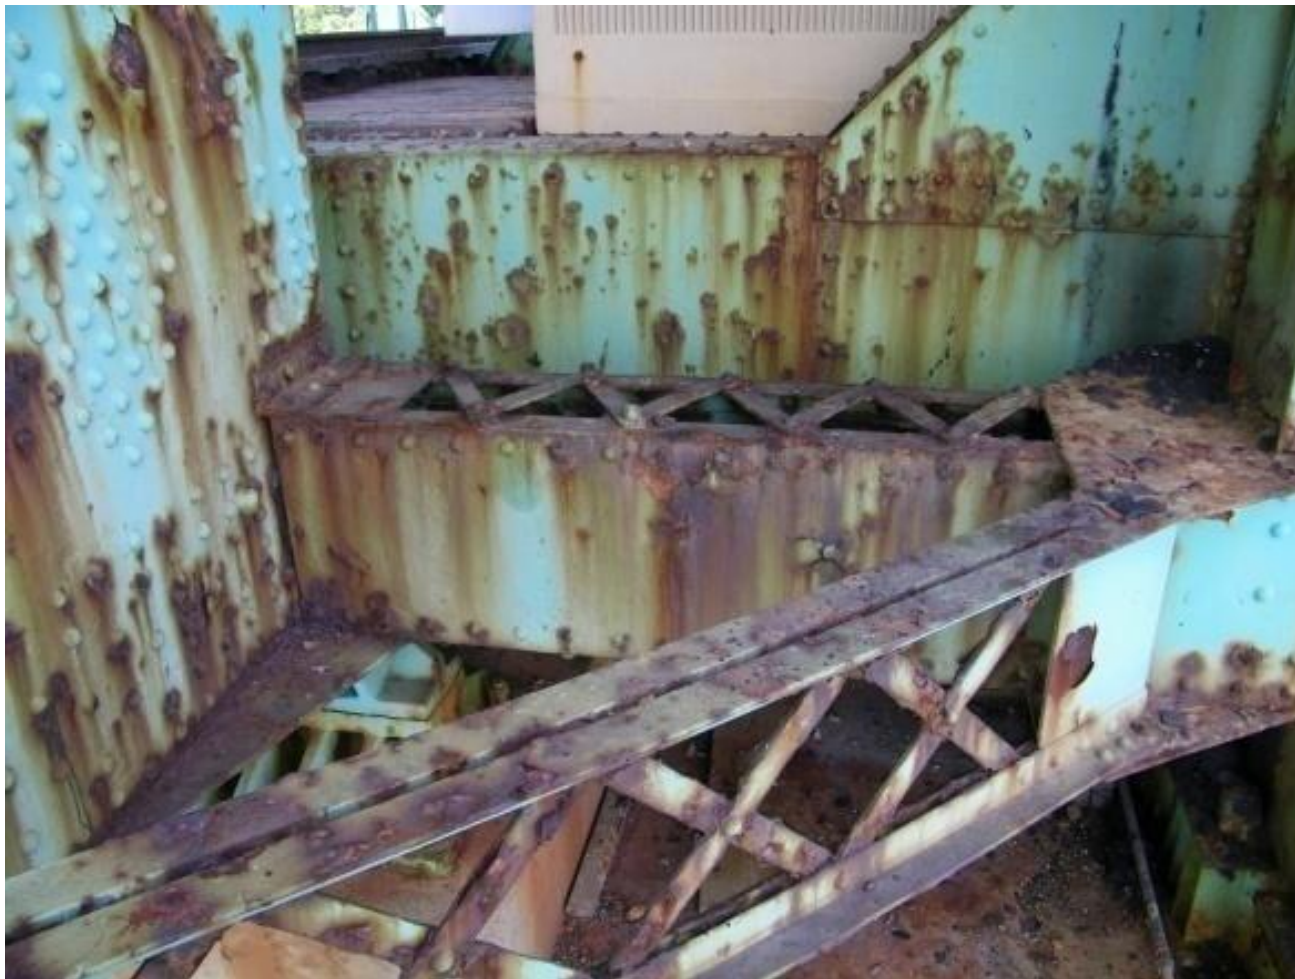
Paint condition at the movable span guide
frame
